New Hampshire Volunteer Lake Assessment Program

2002 Interim Report for Onway Lake Raymond

Onway Lake, Raymond

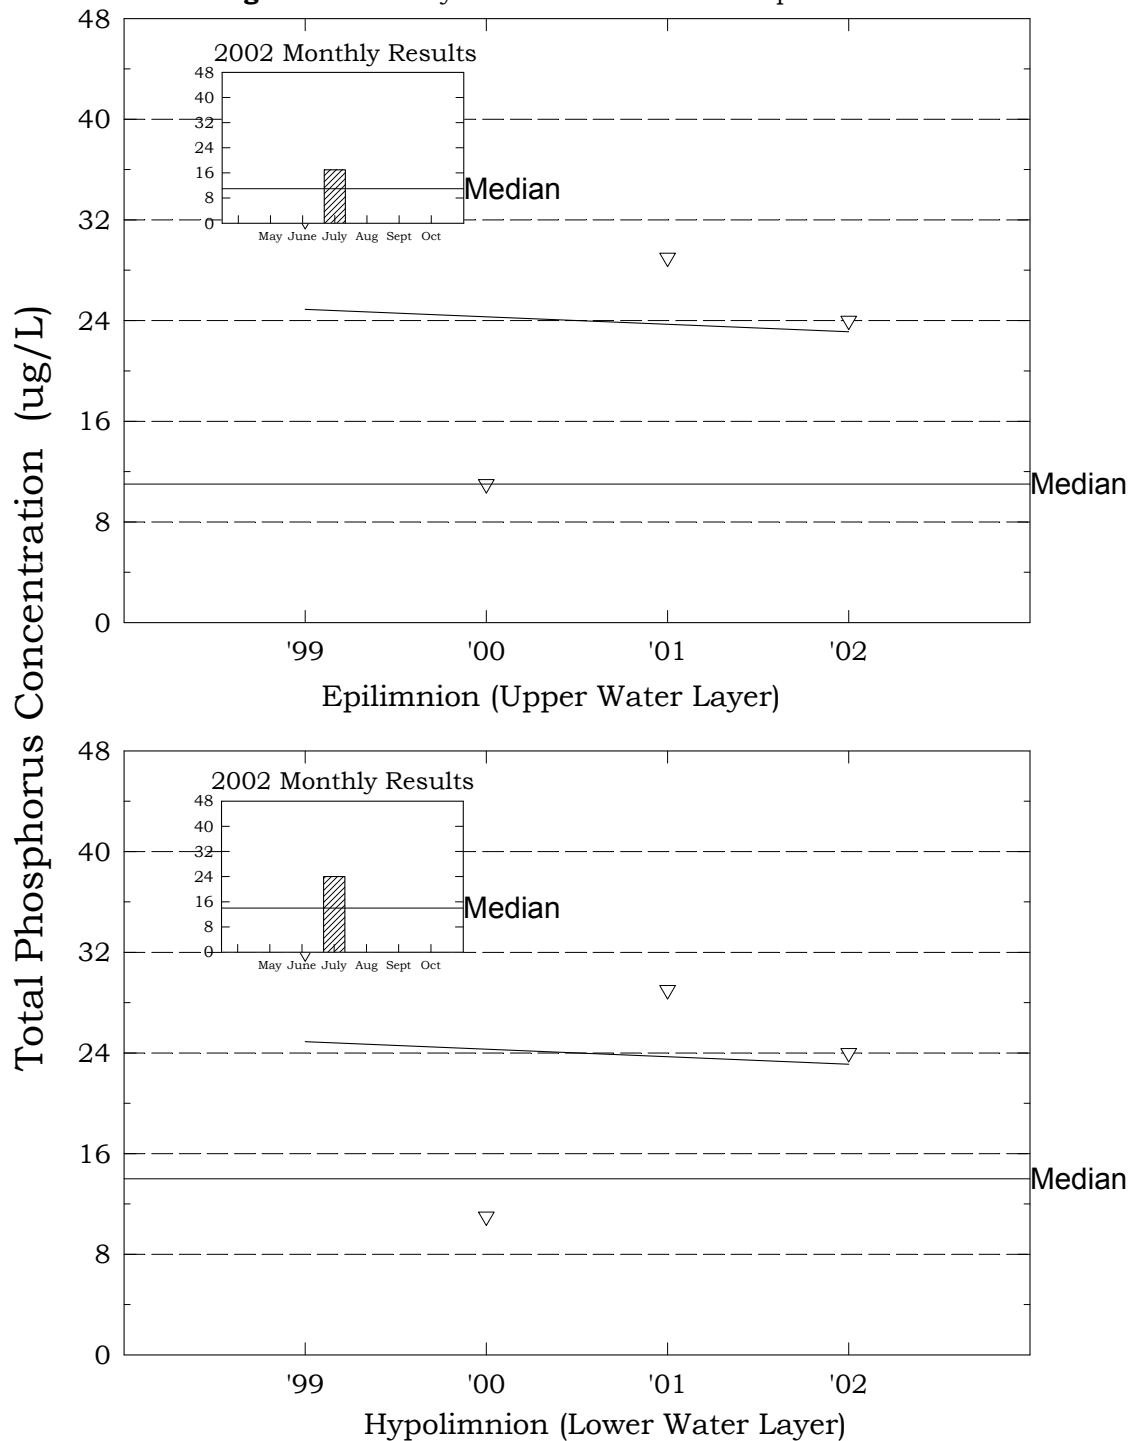
Figure 3. Monthly and Historical Total Phosphorus Data.

- **Figure 3 and Table 8:** The graphs in Figure 3 (Appendix A) show the amounts of phosphorus in the epilimnion (the upper layer) and the hypolimnion (the lower layer); the inset graphs show current year data. Table 8 (Appendix B) lists the annual maximum, minimum, and median concentration for each deep spot layer and each tributary since the lake/pond has joined the program.

The historical data for the epilimnion (upper layer) and the hypolimnion (lower layer) show that the 2002 total phosphorus mean is **greater than** the state median. Overall, visual inspection of the historical data trend line for the epilimnion and the hypolimnion shows **a variable** total phosphorus trend, which means that the concentration has **fluctuated** since monitoring began. Please remember, these trends are only based upon a limited amount of data.

One of the most important approaches to reducing phosphorus loading to a waterbody is to continually educate watershed residents about its sources and how excessive amounts can adversely impact the ecology and value of lakes and ponds. Phosphorus sources within a lake or pond's watershed typically include septic systems, animal waste, lawn fertilizer, road and construction erosion, and natural wetlands. If you would like to educate watershed residents about how they can help to reduce phosphorus loading into the lake/pond, please contact the VLAP Coordinator.
